Case Study

PRO-CS1

Shaver's Way Covers Cut Costs by Over 50%

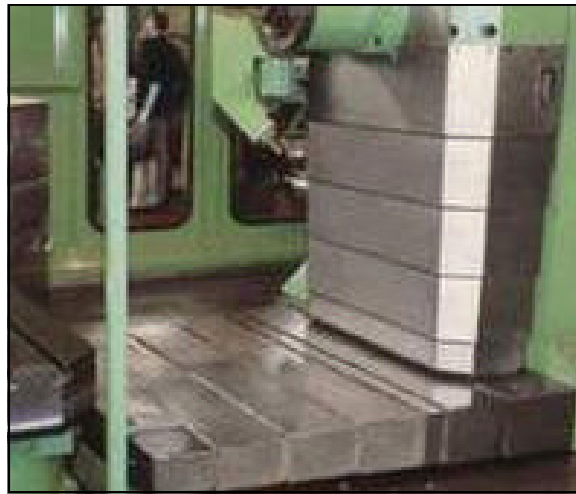
A leading automotive parts supplier found themselves incurring large and frequent repair costs for their way covers.

After careful analysis, Shaver discovered that the chip conveyor alignment was off resulting in chip buildup and the need for constant repair. Shaver helped realign the conveyor and also installed a replaceable wiper system on the covers.

The solution was *instrumental* in cutting the plant's annual \$100,000 repair cost by over 50% to \$43,675 and improving productivity by reducing machine downtime required for repairs.
